# Unknown Spitfire crash Huijbergen

Joop Hendrix / Marnix Vinke Coen Cornelissen

Planehunters Recovery Team 12/17/2020

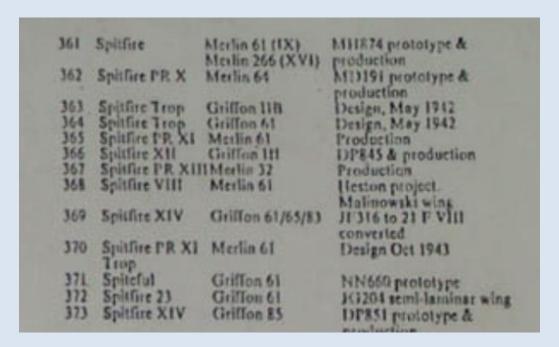
Parts are stamped with 300 numbers. An example of these numbers seen below

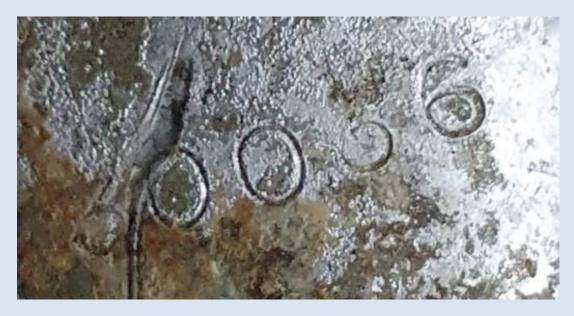
A 300 number from a Spitfire Mk.I, the number 36 means it is from electrical equipment.

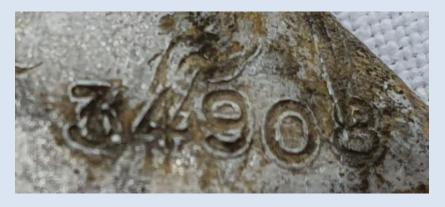
349 refers to a Mk.VC and 08 to a wing part

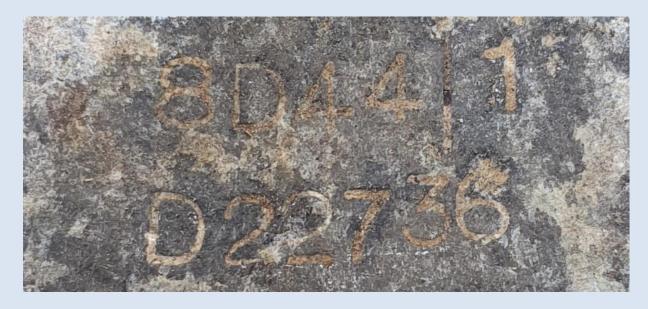
An important find was a part of the elbow intake (D22736) of the carbarateur: This carbarateur (8D44/1) was used on the Mk.IX Spitfire with a Merlin 66 engine and on the Mk.XVI with the Packard build Merlin 266.

Several other D-numbers were found coming from the Merlin 66 engine. The conclusion is, that the crashed aircraft is a Mk. IX or XVI. The Mk. XIV had a Rolls Royce Griffon 65 engine and carried the 9T/40/1 triple entry carbarator.

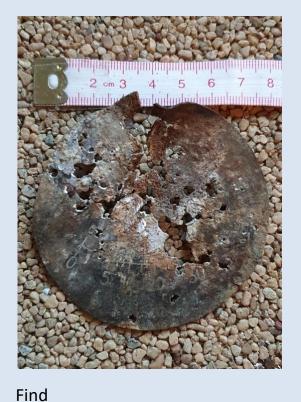
The aircrafts fuel indicator front face was found and was used on Mk. I, V, IX or XVI. Another proof the crashed aircraft is not the Mk.XIV from Malcolmson.

Example 37 gallon fuel gauge

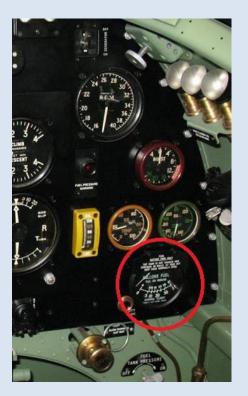
Example Mk.XIV fuel gauge

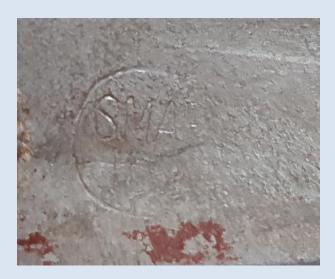
Only 1 inspection stamp found, was from another factory. It is a stamp from the Vickers South Marston factory and reads SMAF. This repair facility fixed damaged Spitfires.

The conclusion: the aircraft was build at Castle Bromwhich. It had been damaged and repaired at/or with parts from South Marston at some point before it crashed.

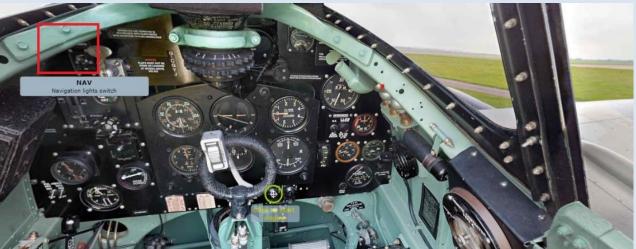
Upper left part of the instrument panel

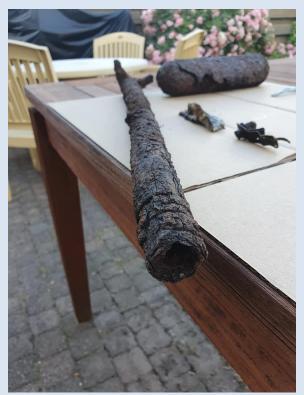
The find of the gas cylinder from the 20MM Hispano MK2 at the crashsite proves that the crashsite is not from Lt/Koes either. The Hispano's were attached in the wings.

Gas cylinder Hispano

The mentioned crash location within a mile of the airfield combined with the find of a part from the Hispano cannon excludes Lt.Koes as the unknown crash.

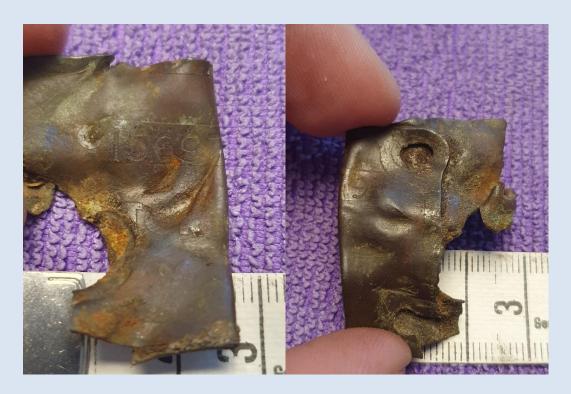
And finally this document had Cipriani's name and the engine number of his Spitfire on it, and matched the find of the engine dataplate (156979) that was recovered at the crashposition in the woods of Huijbergen.

The engine dataplate with the engine number
